**GEOTECHNICAL EXPLORATION REPORT
FRISCO AVENUE BRIDGE
ADOT CONTRACT NO. 2018-006
ADOT PROJECT NO. T0285 01D
CLIFTON, ARIZONA**

Ethos Project No. 2021039
October 6, 2022

**SUBJECT: Geotechnical Exploration Report
Frisco Avenue Bridge
ADOT Contract No. 2018-006
ADOT Project No. T0285 01D
Clifton, Arizona**

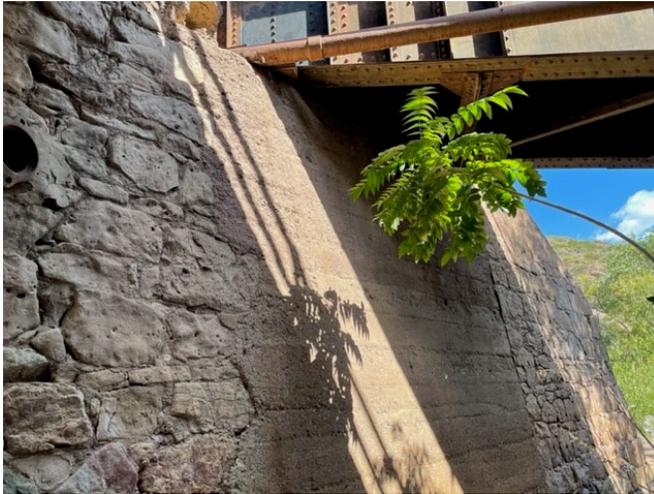
Photo 1 – Looking East at North End of Existing Frisco Avenue Bridge

The new bridge will cross Chase Creek at a point several feet west of where it discharges into the San Francisco River. Chase Creek is channelized with rock grouted walls which stand near

vertical (some batter) to an approximate height of 15 feet. The existing concrete-slab with steel girder single span bridge (which is to be replaced) has a posted 10-ton load rating. The ground surface is relatively flat both north and south of the bridge, likely sloping slightly towards the east to the river. Vegetation consists of scattered trees which parallel both banks of the creek and scattered wild grass. The planned location of the new bridge and shifted roadway alignment is on property owned by the Freeport-McMoRan Mine. This area is generally light industrial with much of the property owned by the mine. Photo 1 shows the bottom of the existing bridge and one of the walls which line Chase Creek.
